INSULATED CONTAINERS FOR BOTTLED WATER (ICB) – PERFORMANCE EVALUATION

by Ben S. Williams

April 2017

Final Report July 2013 – January 2014

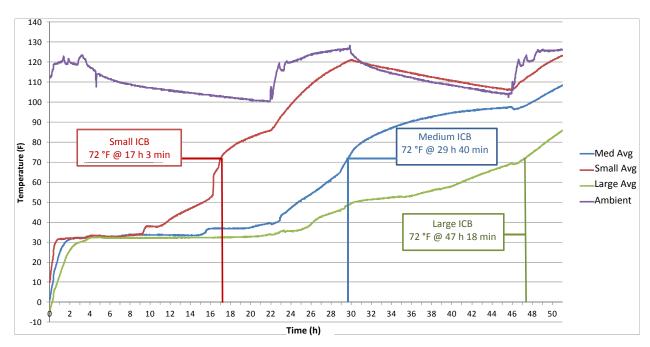
The average water bottle temperatures for the three double-bubble ICBs during the 50-h hot ambient temperature test described in Section 2.2.1 are shown in Figure 21. As can be seen, the more bottled water stored, the longer the average bottled water temperature remained below 72 °F. This is because the larger the thermal mass, the longer it takes to change temperature; therefore, the largest ICB took the longest to have its water bottles heat up.

Figure 21: Hot Ambient Temperature Test - Double Bubble ICB Average Bottled Water Temperatures

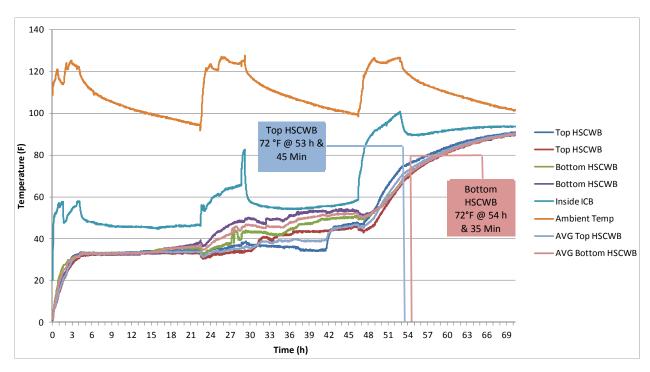
The average temperatures recorded from the hot ambient temperature test described in Section 2.2.2 are shown in Figure 26 from each HSCWB for nearly 70 h of testing. During this test the HSCWBs were positioned one on top of the other, hence the "Top HSCWB" and "Bottom HSCWB" readings. As can be seen when comparing the data in Figure 26 with that in Figure 24, the HSCWBs stored in the large ICB were able to remain below 72 °F for well over 6 h longer than the bottled water in the large ICB (6 h 27 min longer for the top HSCWB and 6 h 50 min longer for the bottom HSCWB). This reinforces the thermal mass principle mentioned in Section 3.2.1: the more frozen water that is stored, the longer that water will take to heat up.

Figure 26: Hot Ambient Temperature Test – Large ICB HSCWB Water Temperatures

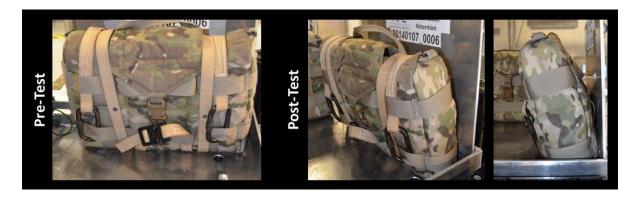
Figure 4 shows the pre and post-test state of the small ICB utilizing the 550 Paracord restraint techniques. No failures were noticeable across exposure rates, though the small ICB was typically tilted away from the back plate post-test. Note, pre-test the pack was secured tight

against the back plate and the Paracord was retightened after each test. High speed video showed that the system moved upwards before being restrained, this movement providing the slack in the restraint system that allowed it to end in a forward tilt position. Similar response characteristics were noted for both the 7 and 9 m/s tests.

Figure 5: Small ICB with 550 Paracord pre-test (left) and post-test (right) state

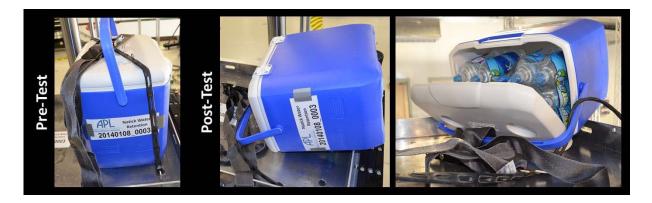
Figure 14 shows the pre and post-test state of the COTS with the standardized strap restraint. For all tests in this configuration, the COTS was overturned, but the contents were exposed only

once. In review of the high speed video, the standardized strap resisted the initial upward motion, and due to the routing induced a rotation on return to earth which caused the COTS to land on its side. The larger upward thrust during the 9 m/s tests allowed for a greater amount of rotation which induced the partial ejection of the water. Additionally, Figure 15 shows the crushing damage sustained by the COTS at the highest exposure level of 9.0 m/s.

Figure 14: COTS with standardized strap pre-test (left) and post-test without ejection (center/right) state
